Manhole Inspection Summary

Manhole # **S37C__035MH**

Insp Date: **8/22/08 2:43 PM**

Location Address: **rear 301 n gay st**

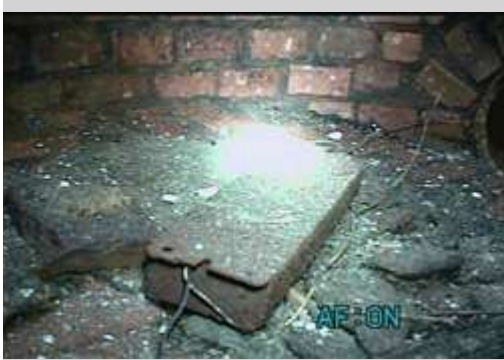
Miscellaneous

channel debris

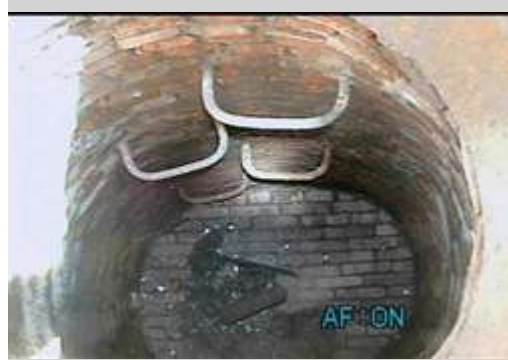
Defect 1

Steps Count: **4** Missing: **0** ☒ **Corroded**

steps

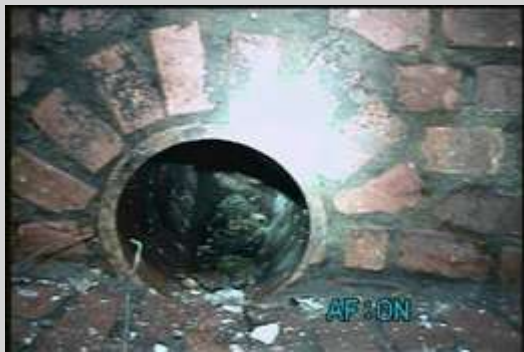
12 O'Clock Outflow

8 in. Circular Gravity Sewer
Pipe Out @ 12 O'Clock

Deposits: ☐ None ☐ Mud ☐ Sludge ☒ **Debris** ☐ Grease

Silt Depth: 2 (in.) Deposits Extent: **Light**
